Protection from Shoreline Erosion

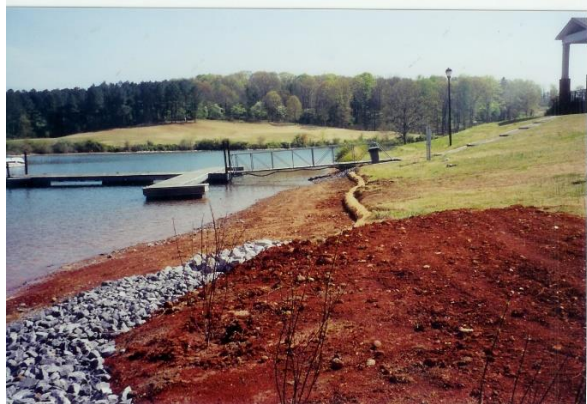
WATeR created a demonstration of various techniques for armoring shorelines along the water edge between the Tanasi Restaurant and entrance to the boat docks in Tellico Village. Included in this demonstration are reaches of riprap, coconut rolls, two types of rock gabions, and vegetation as shown below during construction:

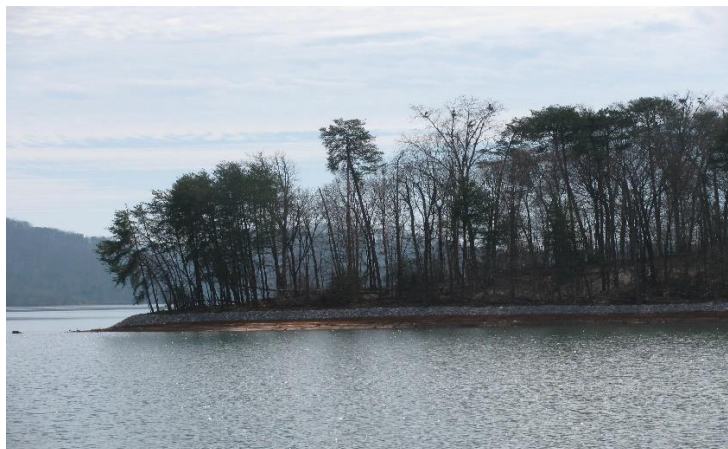
Another application designed specifically for preventing shoreline erosion of Heron Island is visible from the 14th fairway of the Toqua Golf Course in Tellico Village. Boat wakes along the main channel of Tellico Lake near the Clear Creek Boat Ramp were causing severe erosion of the island which was a rookery for Blue Herons. WATeR independently raised \$40,000 to place riprap along 700 feet of badly eroding shoreline under the guidance of TVA.
