**Water Quality Investigation  
of  
Three Embayments of Tellico Reservoir**

**ADDENDUM:  
FOLLOW UP SAMPLING IN 2017**

**Water Quality Improvement Committee  
Watershed Association of the Tellico Reservoir**

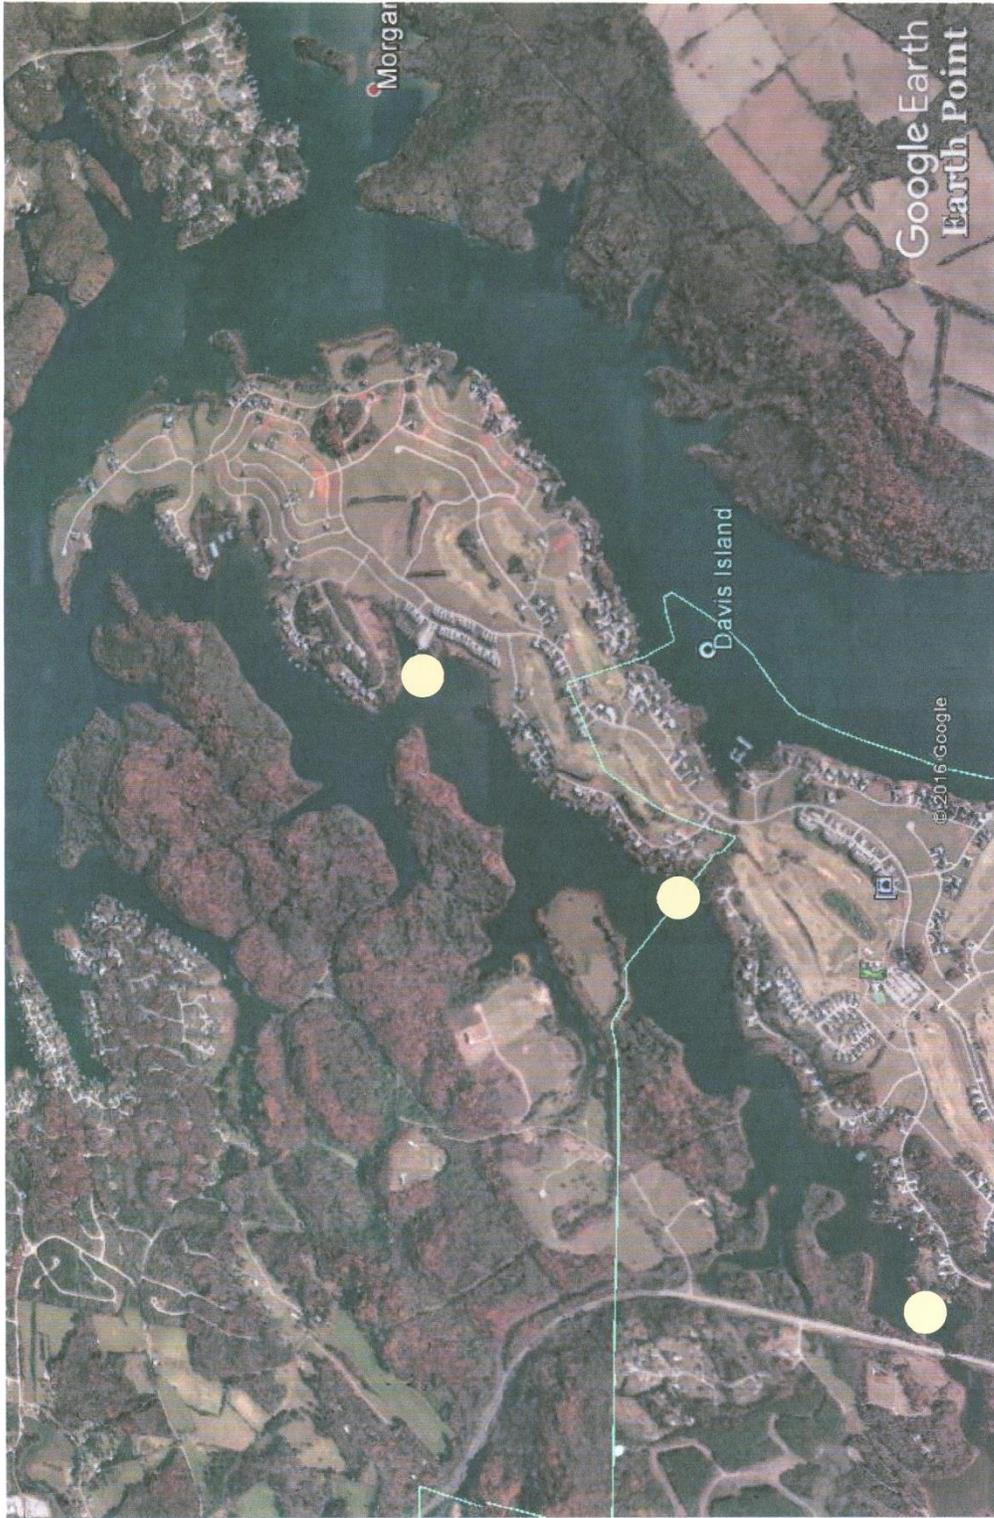
Figure 2: Aerial Photograph of Sample Sites in Bat Creek Embayment

The three sample sites for each embayment are denoted in aerial photographs presented in Figures 2, 3, and 4.

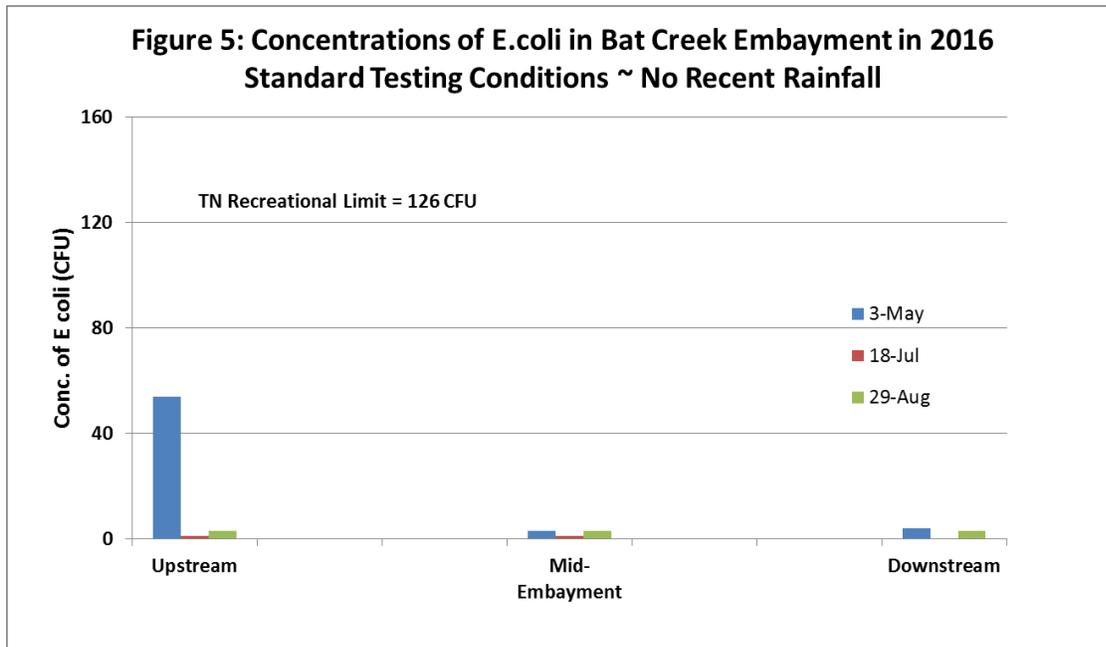
The E.coli concentrations at the three standard sampling sites, for all the sampled months, May to September, ranged from 0 to 120 colonies (per 100ml) with an overall geometric mean of 5.6 (N=12) (Figures 5 and 6). These values are well below the geometric mean criteria of 126 colonies and the absolute criteria of 487 colonies for lake waters to be classified suitable for recreational use (TN. State Statute Chapter 0400-40-03, April 2013).

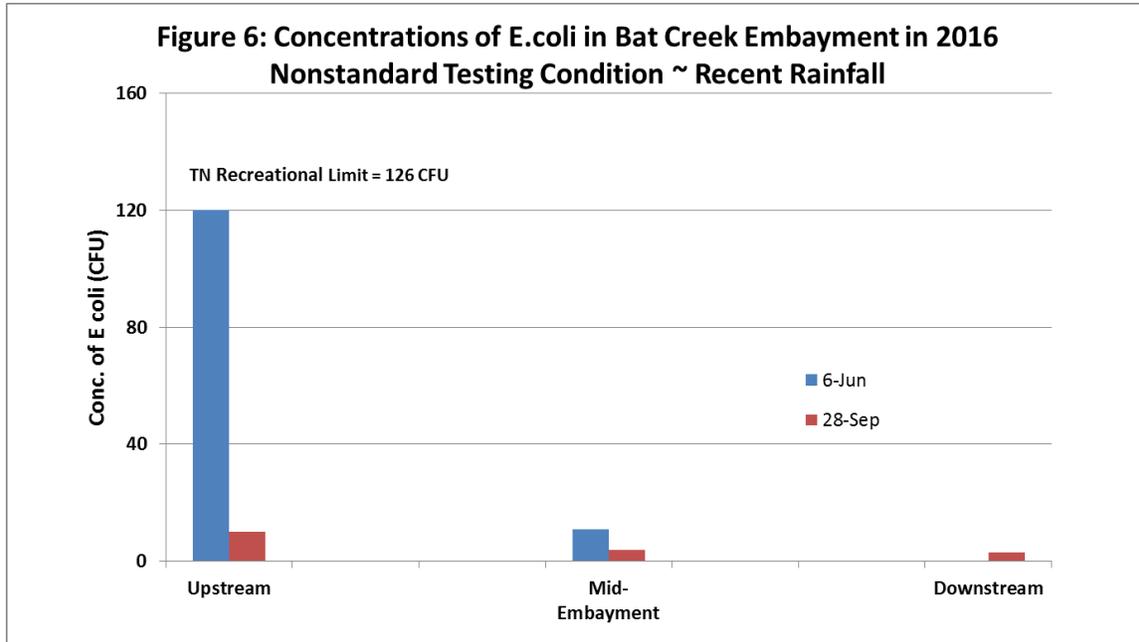
The maximum E.coli concentration found in the Bat Creek embayment was found in the June sampling that occurred after several heavy rain events (Figures 6 and 8). The June sampling event occurred about 24 hours after a two day rain event where 4.03 inch of rain fell. This rain event was preceded by a 1.49 inch rain, with only a 24 hour delay between the two events. The creek flowing into the embayment after this rain event was anticipated to have a very high E.coli count. Sampling by WQIC the previous month (May) as part of the Bat Creek Supplemental Environmental Project (SEP) found the E.coli levels where the creek entered the embayment to be high at 870 colonies (per 100ml). There had only been a trace amount of rain preceding that sampling. So, with this heavier rain event, instead of collecting a downstream embayment sample, a sample was collected in the pool above Route 72 to get better insight into what influence the creek was having on the E.coli concentration of the embayment. The E.coli concentration at the original upstream site located at the Highway 72 bridge, was 120 colonies. (This site was the farthest a boat would normally travel in May when the lake was filling from the lowered winter pool level). An alternate sample was collected from the pool upstream of Route 72 (Refer to figure 8 for illustration of the upper embayment sample sites). Although the sample from the pool above Route 72 was collected only about 1,500 feet from the Route 72 bridge site, the E.coli concentration in that

pool was high at 1,700 colonies. Moving downstream from the 72 bridge the E.coli concentration at the mid-embayment sample site was only 11 colonies. It is not known if or how far that slug of high E.coli water extended downstream into the Bat Creek embayment of Tellico Reservoir in the days after the sampling.

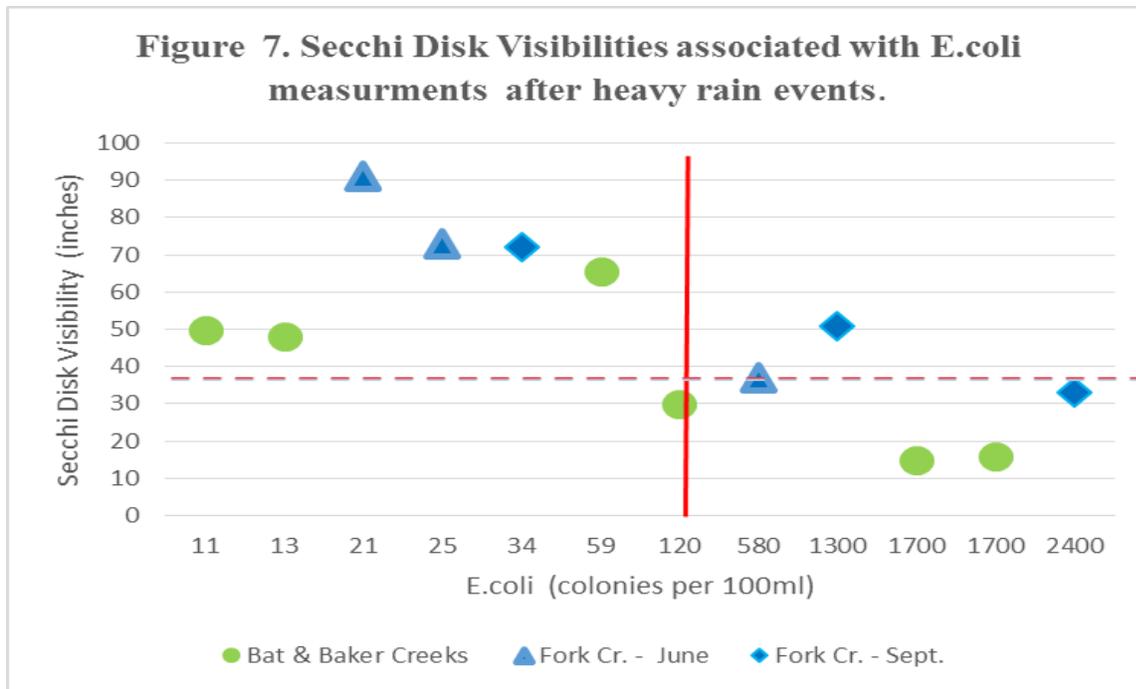
The high E.coli concentrations found after the heavy rain event in June were associated with muddy or murky water where secchi disk visibilities were 30 inches or less for Bat Creek and Baker Creek and less than 40 inches for Fork Creek. (Figure 7). For the September rain event high E.coli were found in Fork Creek with clearer water. A heavy rain in early fall can wash in lots of organic matter from harvested fields. This organic matter seems to neutralize the colloquial properties of mud (personal observation of the co-author).

It is suggested that after a heavy rain event the public should exhibit caution in waters of the upper part of the embayment, and any waters that appear muddy or murky with mud. The high E.coli concentrations were associated with muddy or murky water where secchi disk visibilities were 30 inches or less (Figure 7).

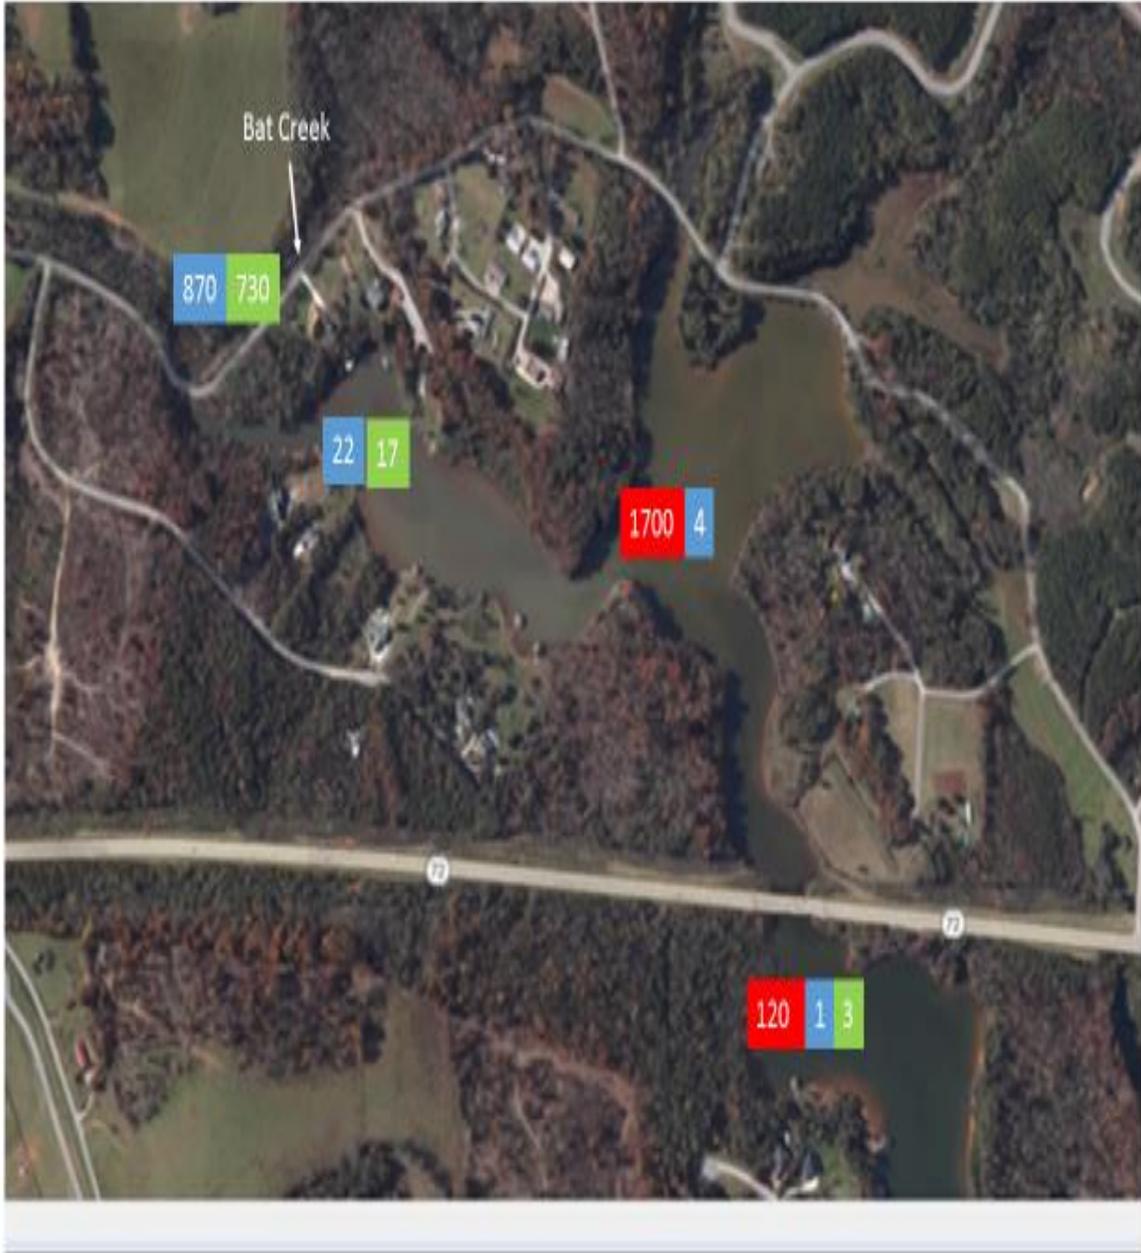
Additional sampling was undertaken in July and August to further evaluate what influence the creek was having on E.coli in the embayment. Sampling by WQIC in 2016 for the Bat Creek Supplemental Environmental Project (SEP) found the E.coli levels where the creek entered the embayment to be high: In the uppermost pool where the creek entered the embayment, the E.coli ranged from 250 to 870 colonies (per 100ml) with a geometric mean of 604 (n=5). During July and August an additional sample for this embayment study was collected in the pool immediately downstream of the Lakeside Drive crossing of Bat Creek, a mere 1200 feet downstream from where samples were collected for the Bat Creek SEP project. Although E.coli levels in the creek were 870 and 730 colonies, 5 and 7 days, respectively, prior to sampling in the downstream pool, E.coli in the pool was only 22 and 17 colonies, respectively. In the next pool downstream, the pool above the 72 bridge, where the E.coli concentration was 1700 colonies in June, it had fallen to a mere 4 colonies in the July sample.

Figure 8. E.coli colonies (MPN/100ml) measured in the upper pools of the Bat Creek embayment. The values in red are those for June, after a heavy rain event. Those values in blue are for the month of July, and green for the month of August.

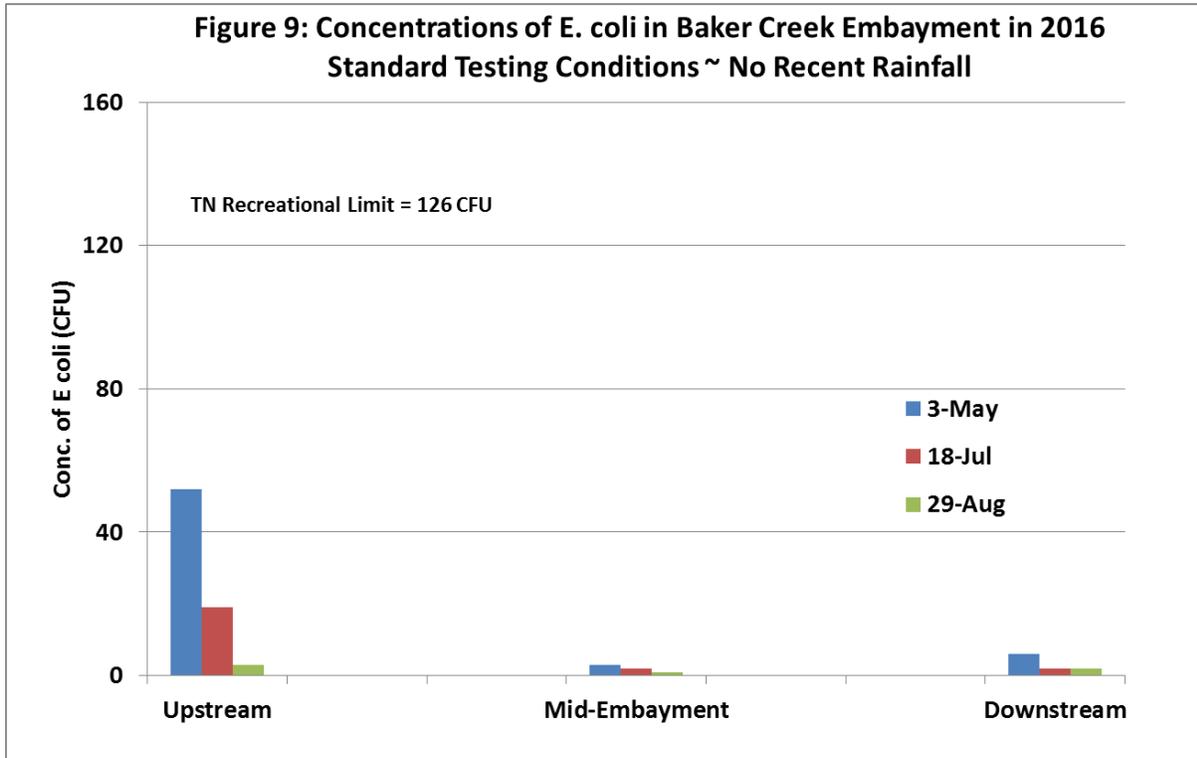
The E.coli concentrations during May, July, and August (Figure 9) ranged from 1 to 52 colonies (per 100ml) with an overall geometric mean of 4.2 (N=9). These values are well below the geometric mean criteria of 126 colonies per 100ml and the absolute criteria of 487 per 100ml for lake waters to be classified suitable for recreational use (TN. State Statute Chapter 0400-40-03, April 2013).

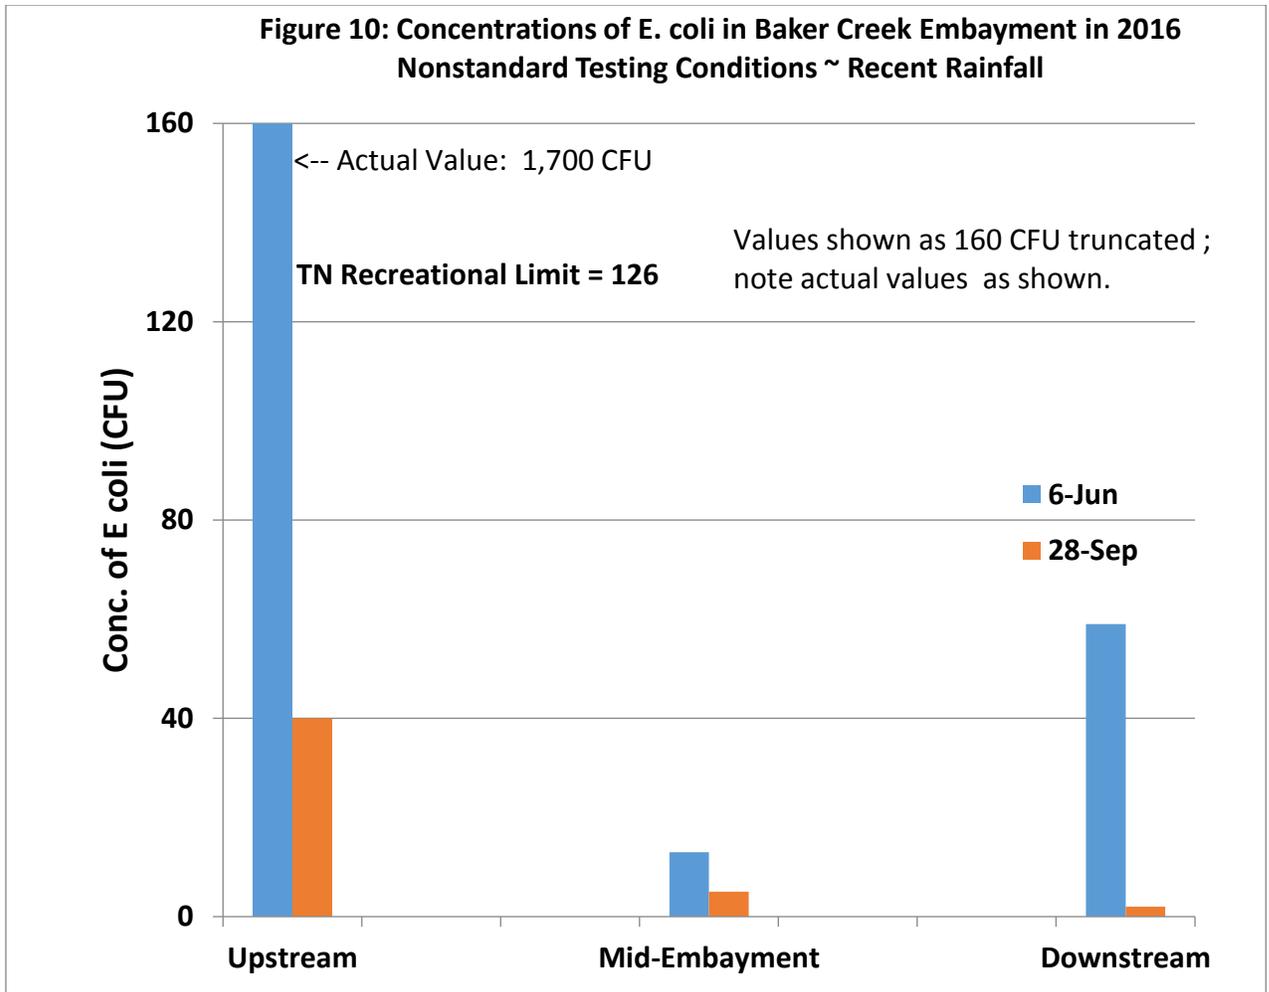
During the months of June and September, when sampling occurred after heavy rains (Figure 10), most of the E.coli concentrations remained low, 2 to 59 colonies, except the uppermost sample site in June the concentration was 1700 colonies. The high E.coli, like that at Bat Creek, was associated with turbid muddy water.

During the June rain event there was a minor spike in E.coli at the downstream station near a residential area. Though this spike was well within acceptable levels it suggested that E.coli during rain events originated from sources other than the incoming creek.

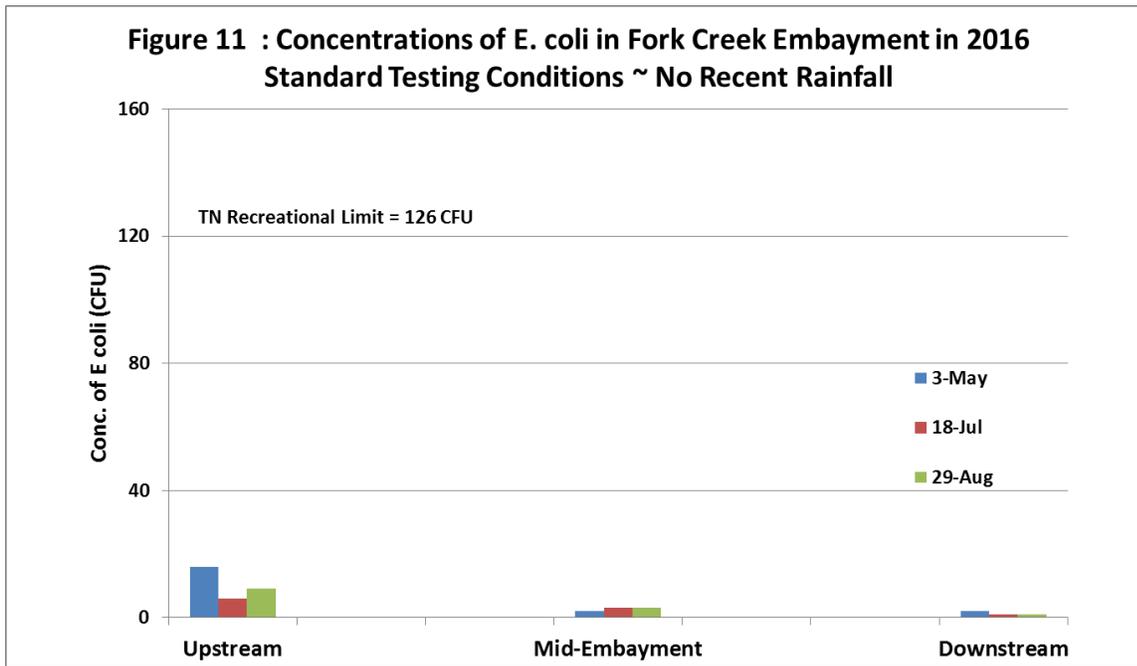
The E.coli concentrations during May, July, and August (Figure 11) ranged from 1 to 16 colonies (per 100ml) with an overall geometric mean of 3.2 (N=9). These values are well below the geometric mean criteria of 126 colonies per 100ml and the absolute criteria of 487 colonies per 100ml for lake waters to be classified suitable for recreational use (TN. State Statute Chapter 0400-40-03, April 2013).

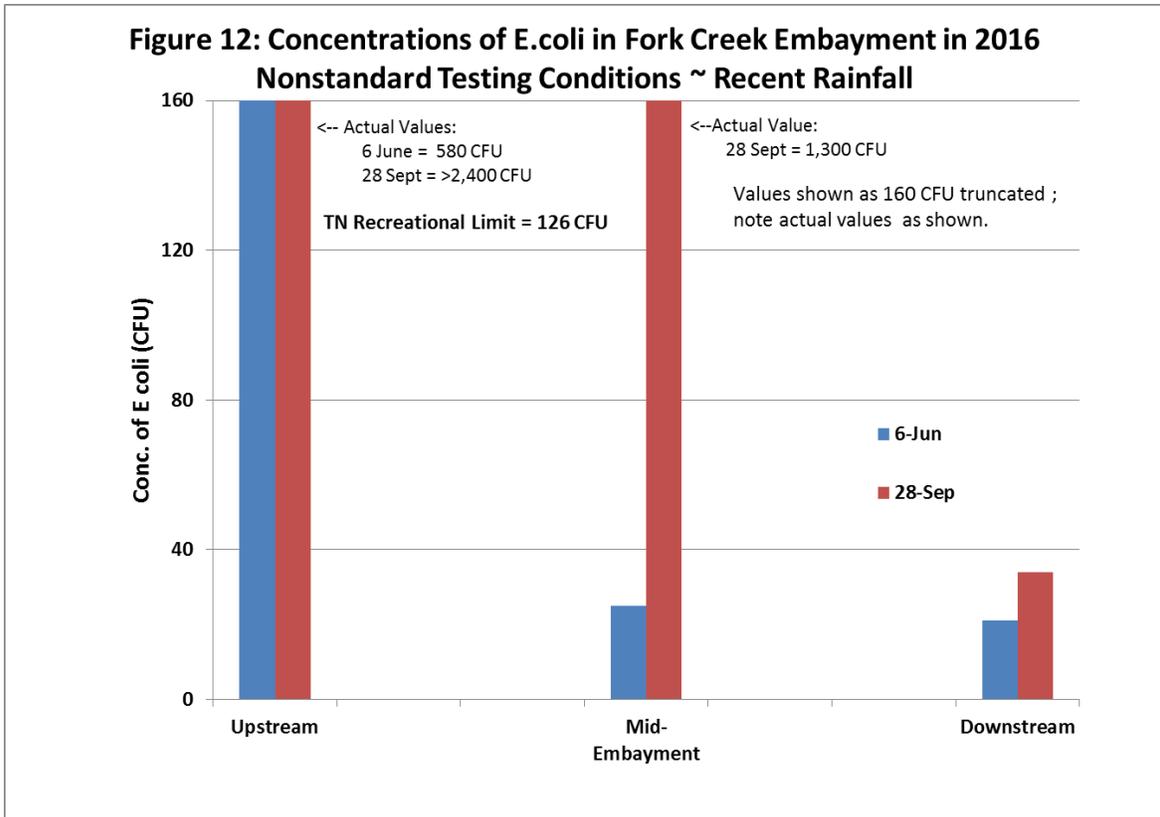
During the months of June and September, when sampling occurred after heavy rains, several samples had E.coli concentrations in excess of 500 colonies (Figure 12).

The elevated concentrations of E.coli at the upstream sample site following periods of heavy rainfall were as expected and consistent with results from the other two embayments. However, the high concentration of E.coli recorded at the mid-embayment site was not only inconsistent with data at this location following the June rainfall, but also the trend from the other two embayments following heavy rainfall. Additional sampling of this embayment after a major rainfall event is planned for the summer of 2017 to define the trend of E.coli concentrations over several days.

The high E.coli after rains, unlike Baker and Bat Creeks, did not always appear associated with muddy or turbid water. Where in Bat and Baker Creeks high concentrations of E.coli were found in water with secchi disk visibilities 30 inches or less, for Fork Creek, after heavy rains, high concentrations of E.coli were found in water with higher secchi disk visibilities (Figure 7). . A heavy rain in early fall can wash in lots of organic matter from harvested fields. This organic matter seems to neutralize the colloquial properties of mud (personal observation of the co-author)

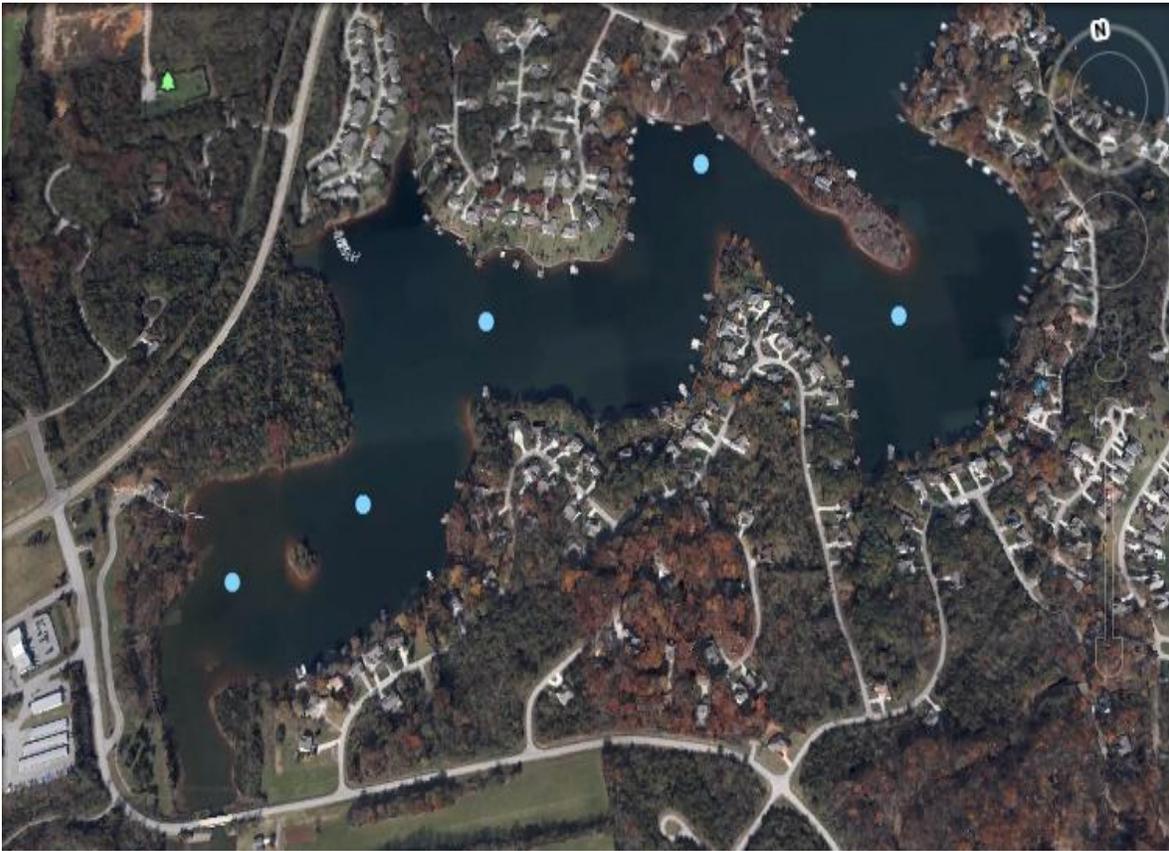
Sites sampled in Fork Creek embayment in 2017.

Site	Site Name	Location
Fork 1	Mialaqua Bridge	Downstream of Mialaqua Bridge at point in lake about midway along a line between first pier on North shore and first pier on South shore
Fork 2	Inagehi Way Island	1 <sup>st</sup> buoy past island (second buoy)
Fork 3	Chatuga Way shore	past 2nd buoy after island (3rd buoy; green buoy across from Marina) and collect sample in middle of channel out from red pier
Fork 4	Inagehi Circle Point	Upstream buoy of the group of 3 buoys off of the point on Inagehi Circle
Fork 5	Kiyuga Lane Point	Next buoy downstream of the group of buoys; off of point on Kiyuga Lane

Fork 1      Fork 2      Fork 3                      Fork 4                      Fork 5

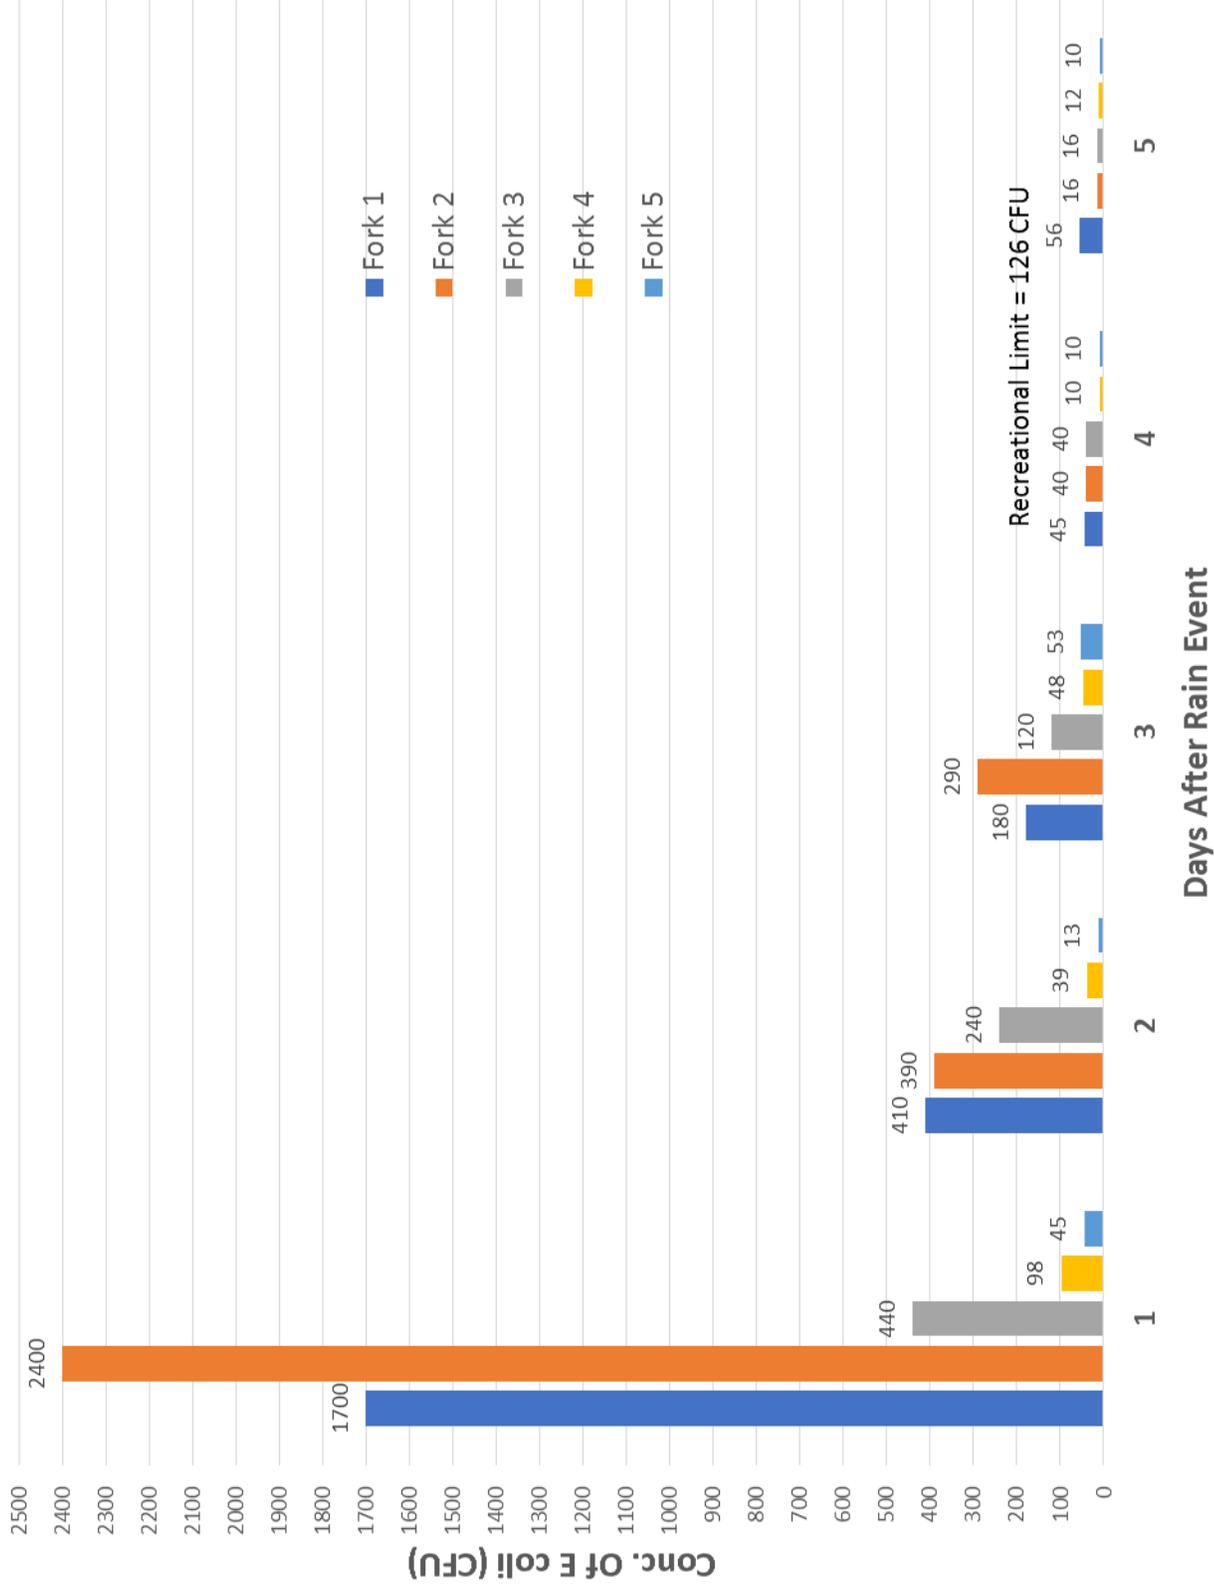
# Concentration of E coli in Fork Creek Embayment for Days After Heavy Rain Event in 2017

Sample site Fork 4 was sampled both in 2016 and 2017. During 2017 the maximum E.coli concentration found was 98 MPN. The E.coli concentration at this site in September 2016 was 1,300 MPN.

During 2017, WQIC volunteers sampled the Fork Creek embayment for five consecutive days after a heavy rain event to determine the penetration of E. coli into the embayment and to measure how long it took for the bacteria to decompose. The results confirmed the WQIC recommendation in 2016 regarding water contact following a heavy rain event. Based on an analysis of the data, **the WQIC advises that people should avoid contact with water in the shallow end of the embayment, where polluted creeks enter the reservoir, for three days following a heavy rain event.** Swallowing or swimming in water contaminated with pathogenic strains of E. coli can lead to an infection, with symptoms of abdominal pain, diarrhea, and fever. E.coli bacteria is an indicator of recent fecal contamination. As such, other more serious pathogens may be present at high concentrations of E.coli.
