# Report on *E. coli* Testing

## Tugaloo Family Park - Tellico Village, TN

### Success Story: Green Infrastructure Improvements Mitigate Bacterial Contamination at Tugaloo Family Park

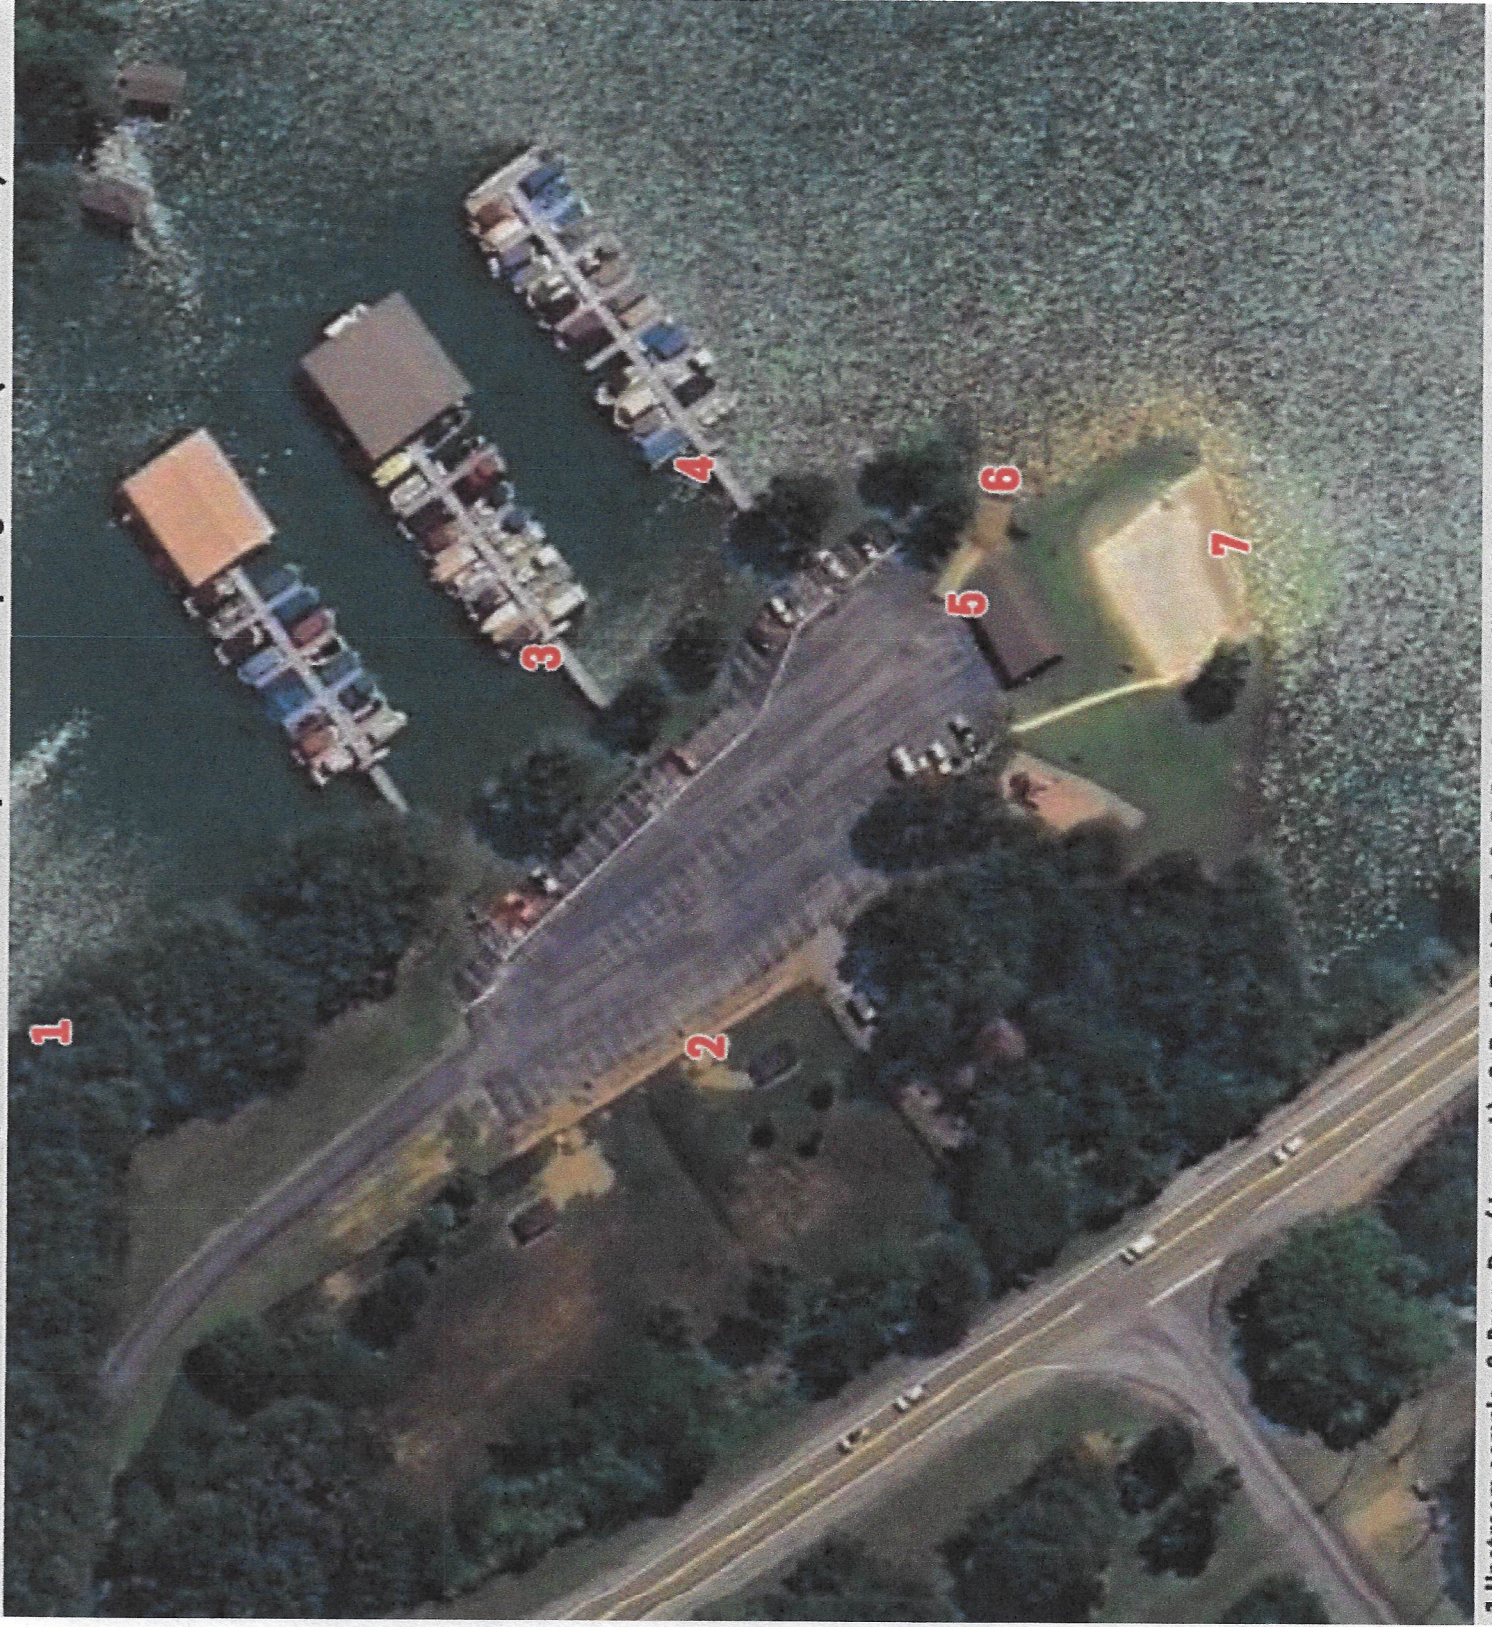
# Aerial View of Tugaloo Beach Family Park Sampling Sites (2021-2025)

1. Upstream sample 2. Rover Run (dog park) 3. Dock B 4. Dock C 5. Pond area pavilion 6. Inlet swale 7. Swimming area

From 2021 through 2025, WATeR conducted regular *E. coli* monitoring at several locations, including Boat Docks B & C, the inlet to Tellico Lake, the Ponded Area near the Pavilion, the Swimming Area, and the Rover Run swale (see attached aerial photo). Results, measured in MPN/100 ml, were compared against Tennessee's revised single-sample recreational water quality standard of 410 CFU/100 ml (effective March 2024). MPN/100 ml and CFU/100 ml are measurements used by laboratories using different test methods but are treated as being equivalent measurements. A summary of results is provided in Table D

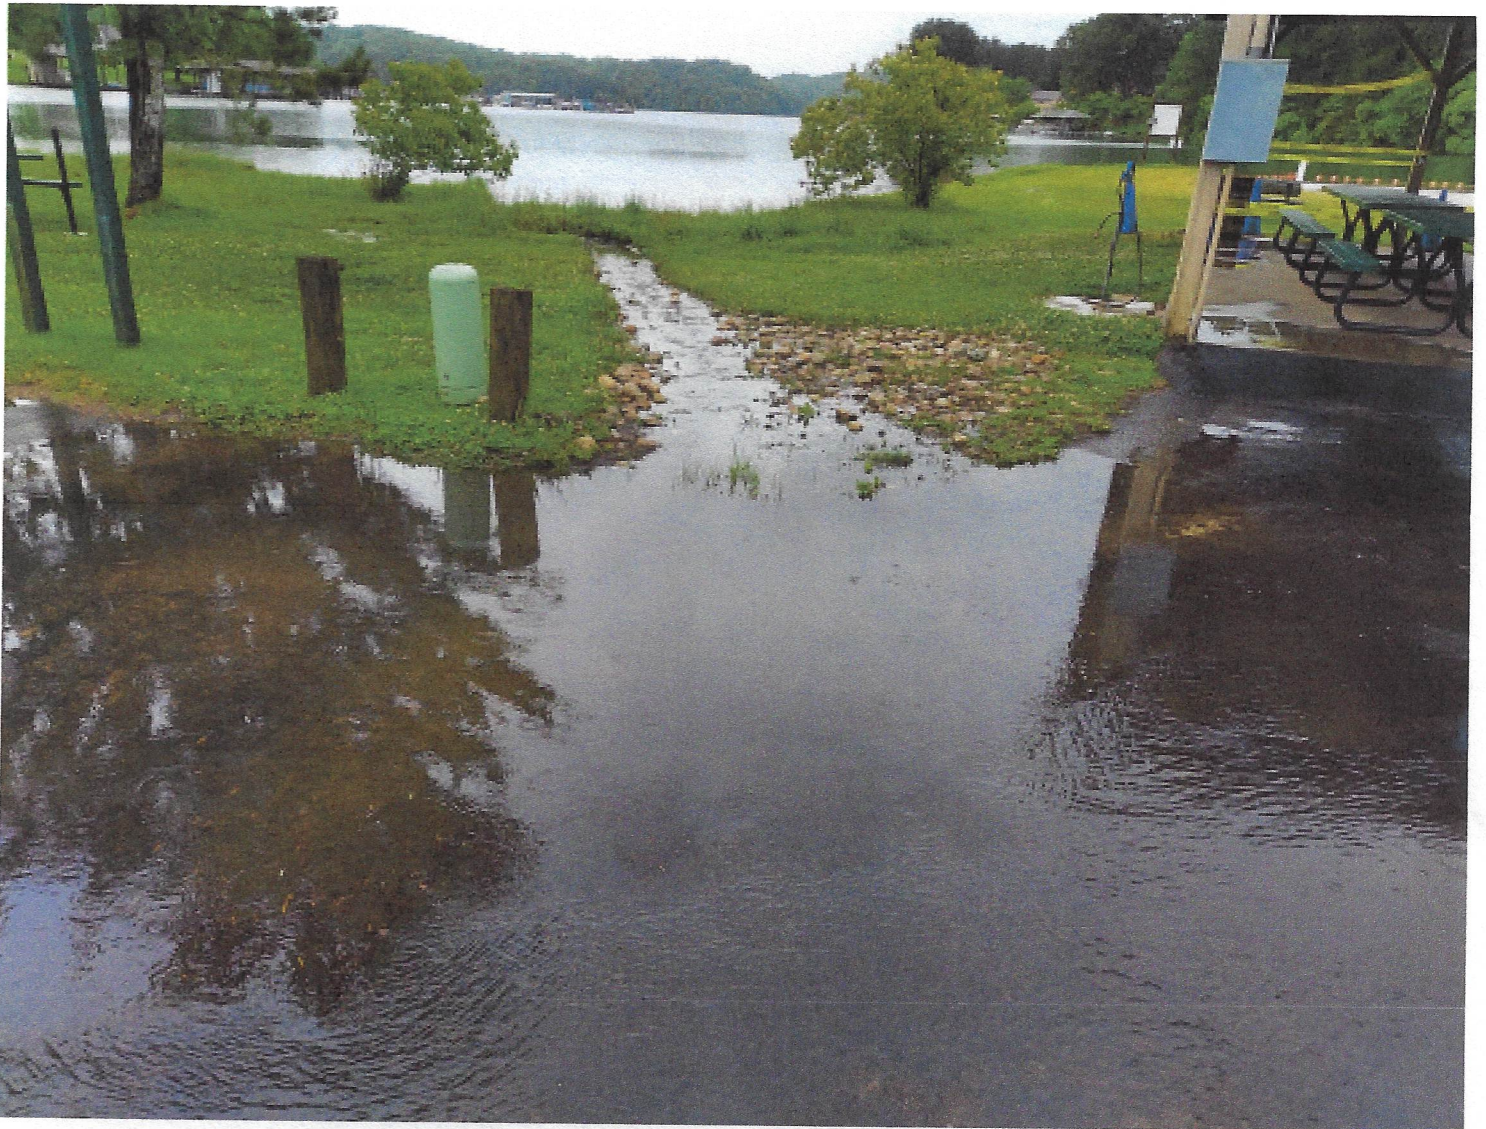
## Site 5 at Tugaloo Family Park (June 2021)

During the early years of sampling, elevated *E. coli* levels were frequently recorded at the Inlet to Tellico Lake and the Swimming Area, often exceeding State standards. Major spikes were associated with heavy rainfall events (>1.0 inch), which likely caused runoff carrying bacteria into the swimming area. On several occasions, concentrations exceeded the saturation limit of the lab analysis, raising significant public health concerns. It appeared that the run-off from the dog park and surrounding area, drained onto the parking lot and was then directed into the drainage swale located immediately adjacent to the lake. This run-off contained elevated concentrations of the *E. coli*

Storm water event prior to installation of Rain Garden and Drainage Swales (2021)

These “green infrastructure” improvements were implemented in 2023, and included the installation of a rain-garden and drainage swale upslope from the swimming area and adjacent dog runs. These features were designed to slow, filter, and absorb stormwater, thereby reducing bacterial contamination before it reached recreational waters.

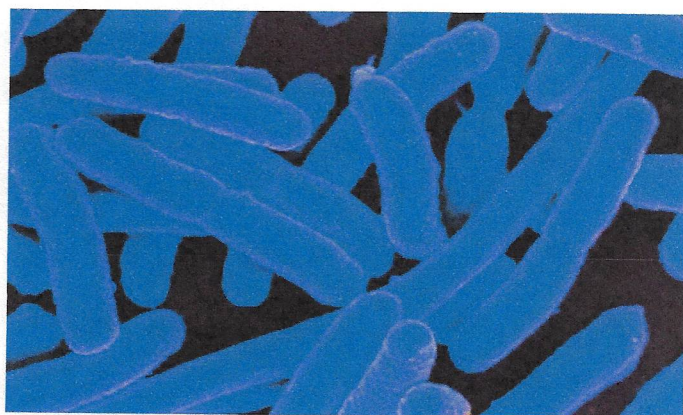
Figure 1. *E. coli* under a microscope. Credit: Photo courtesy of National Institute of Allergy and Infectious Diseases

Water samples are collected to measure *E. coli* (Figure 1) to make sure water is safe for public recreation, such as swimming, fishing or canoeing. *E. coli* is considered an indicator organism, used to identify fecal contamination in freshwater and indicate the possible presence of disease-causing bacteria and viruses (pathogens). Individuals who swim or come in contact with water with elevated levels of *E. coli* and other fecal indicator organisms are at an increased risk of getting sick because of potential exposure to fecal pathogens. Common symptoms of ingesting a pathogenic strain of *E. coli* include vomiting and diarrhea. High numbers of *E. coli* (and other) bacteria may contribute to cloudy water, unpleasant odors, and increased oxygen demand (which may reduce levels of dissolved oxygen in the water).

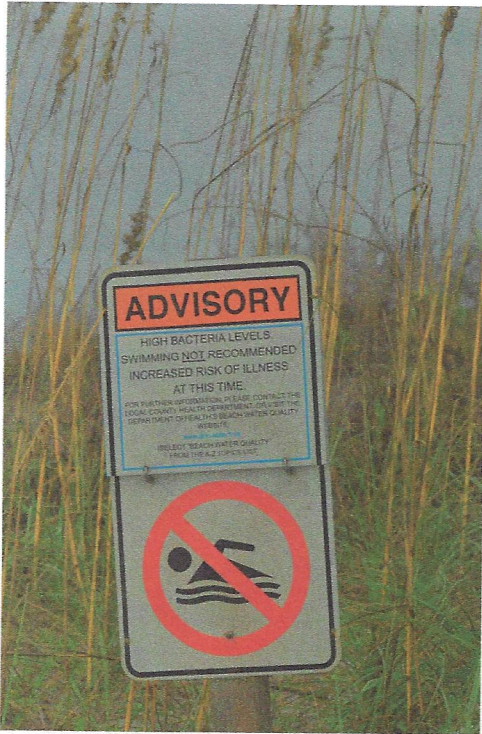
Figure 2. Public advisory warns of high bacteria levels in water. Public advisories can include additional information such as the date of the posting and contact information to check on the status of the posting. Credit: Photo courtesy of USEPA

When elevated *E. coli* concentrations are observed, it is important to respond in a timely manner by collecting additional data, posting a public notice (Figure 2), and/or closing the waterbody to recreational activities. Figure 3 summarizes general actions to take when responding to elevated concentrations.
